# **Adaptive Secondary Mirrors**

Large Binocular Telescope Observatory

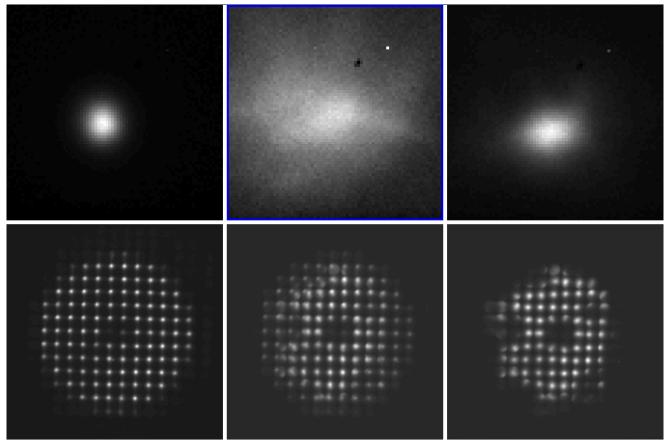
- An ASM failure causes:
  - The shell to "*RIP*" into a rest state.

The guider FWHM before the RIP was 1.1", after the RIP was 1.7"

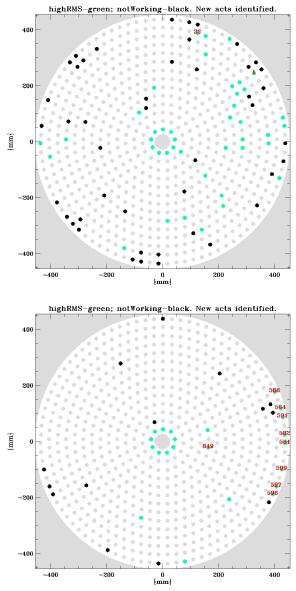
- Actuator Malfunction
  - Detached magnets
  - Dirty contacts
  - Electronics failure
    - Capacitive sensor
  - Voice-coil failure

Note: when ~10% of actuators are removed then performance can be compromised, especially when they are clustered.

black: actuators with non-working capacitive sensor green: actuators with high RMS position reading

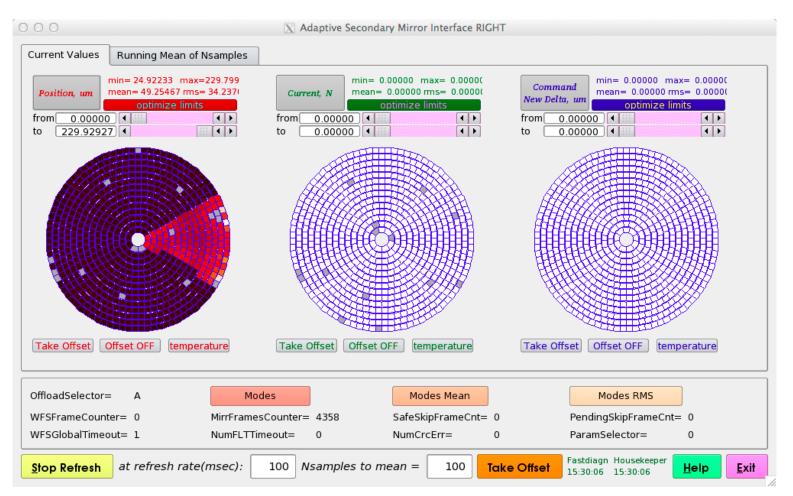
- The "Pie" shape:
  - So-called because of a failure in the electronics or distribution board controlling 1 of 6 sectors of the DM
  - Intermittent to begin with ...

- Mitigation of the "Pie" shape:
  - Open circuit because of a poor connection on the Central Distribution Board. This board carries the signal for the actuator control to the six individual sectors on the back side of the thin shell.
  - For the SX unit the spring contacts were cleaned and replaced.
  - 5 months later the DX unit showed identical behavior.
  - Springs were replaced by pins (used in the VLT unit).
  - Failed after only two days.
  - Currently working on putting back the springs, researching other options (different coating material, improved springs, etc.).
