## Notes on SEDM Collimator clamp replacement on 6/30/16

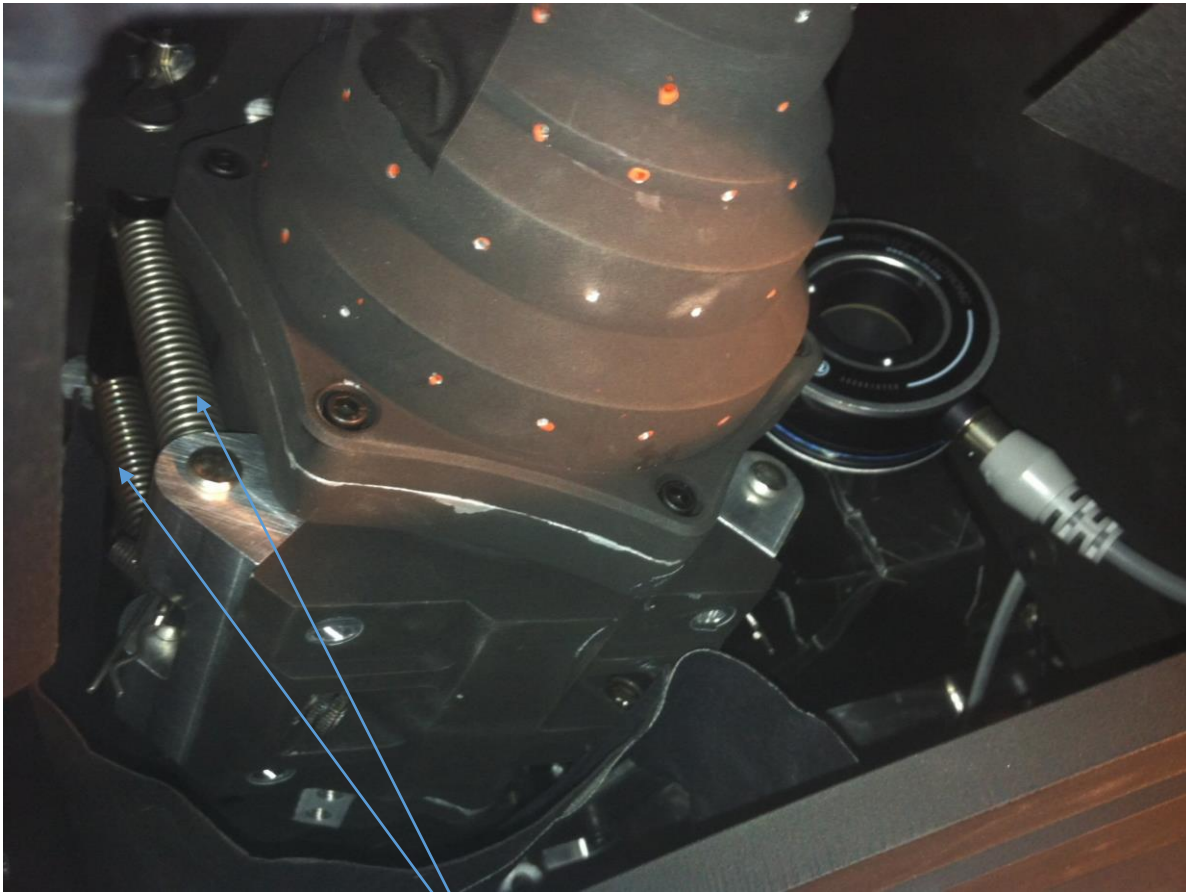
- The clamps (slide 2) are intended to improve stability of the collimator mounting in its vee-block and address the problem of loss of collimator/lenslet alignment that occurred on several occasions (5/5/16, 6/8/16, and 6/24/16)

Original configuration – collimator clamped with tension springs

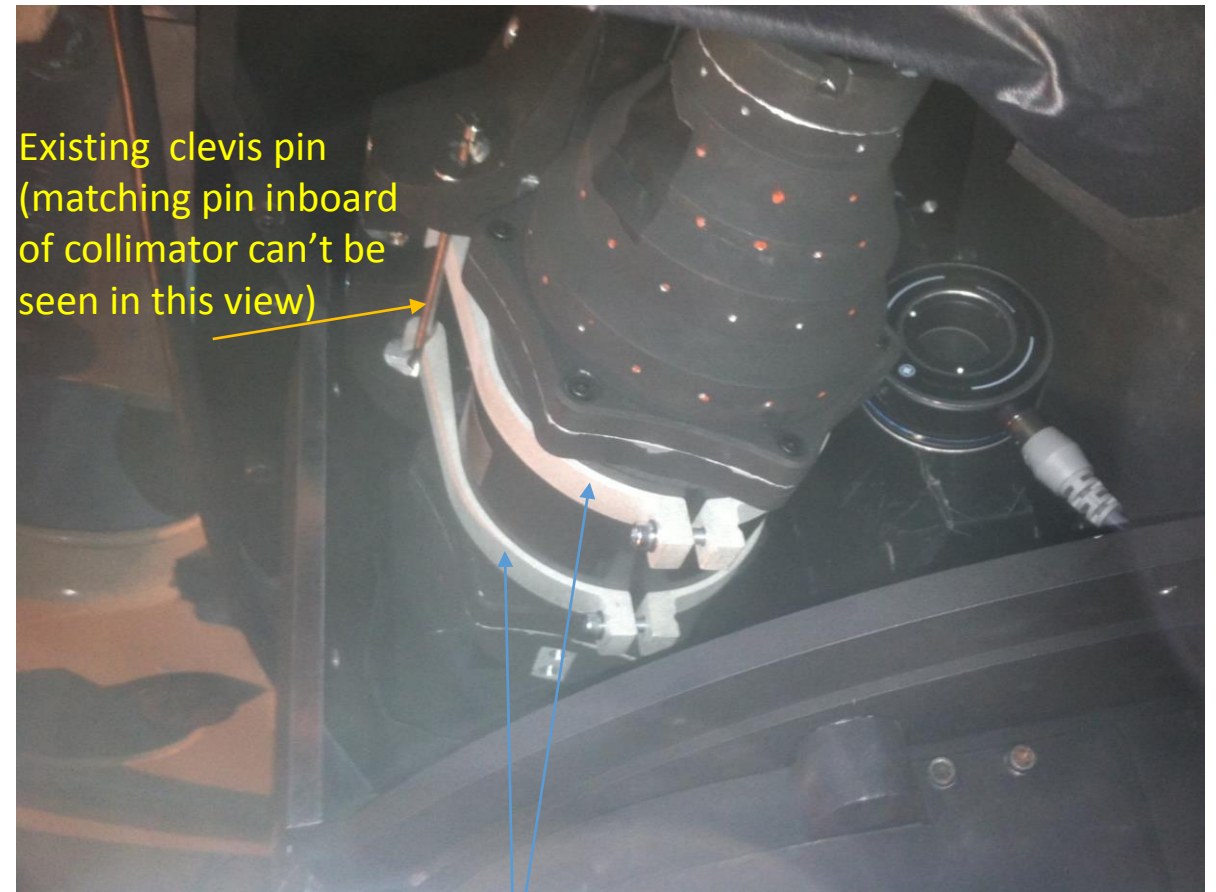
Existing clevis pin (matching pin inboard of collimator can't be seen in this view)

- One of the four clamping arms needed to be slightly modified to fit on the inboard clevis pin. This modification does not weaken it or reduce its stiffness.

New configuration uses rigid clamps that attach to the existing clevis pins

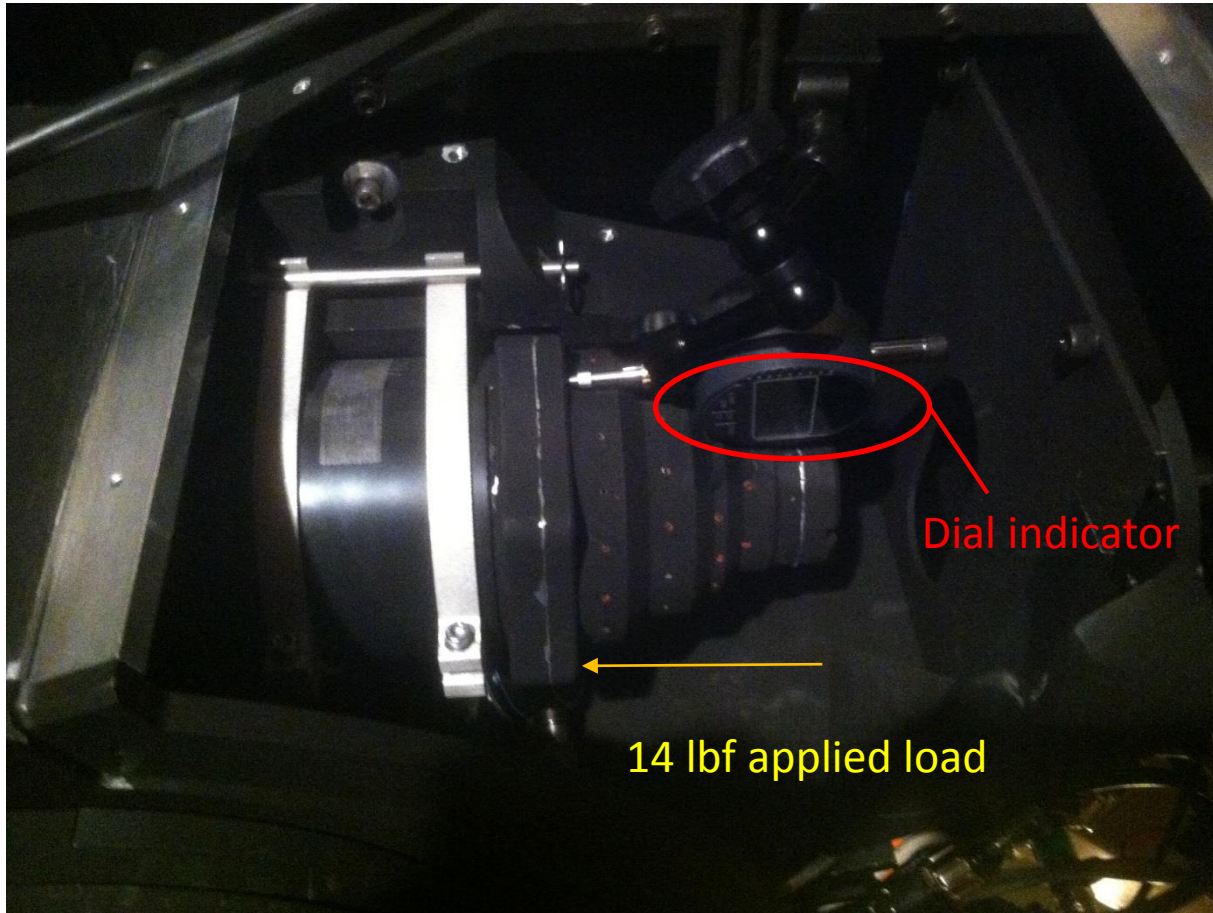
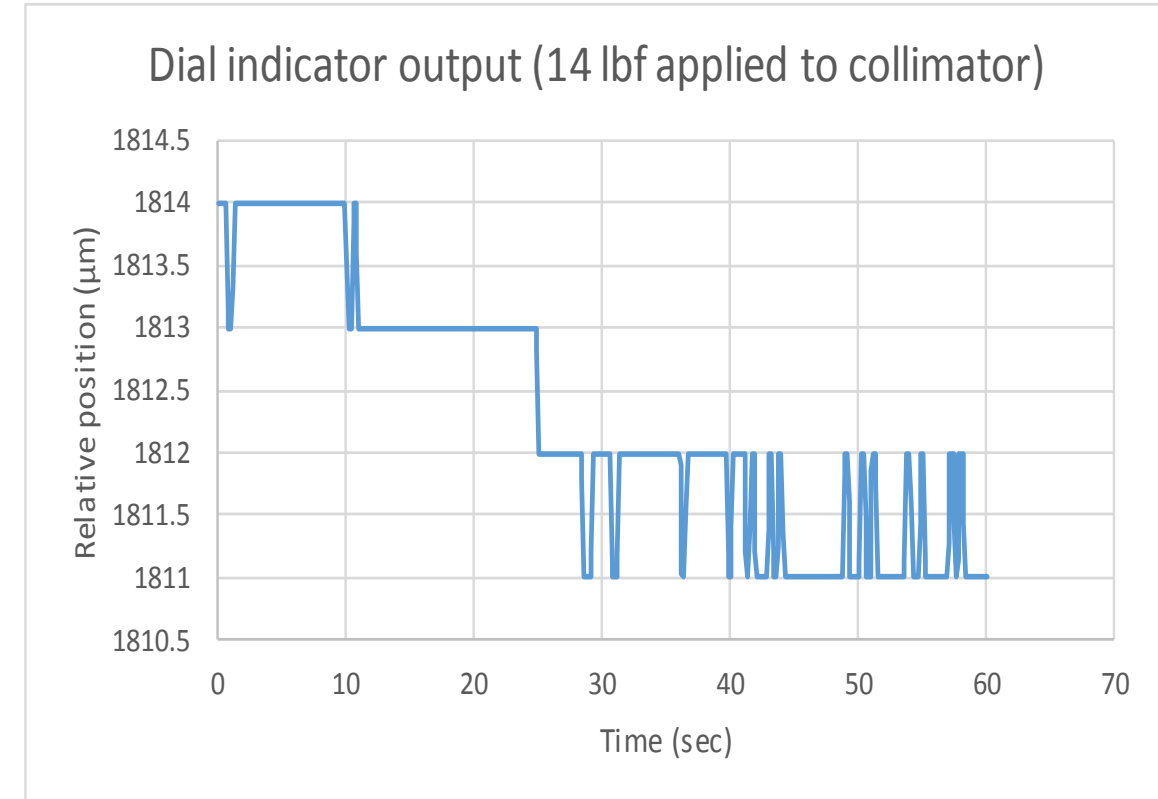
- An axial force (slide 3) comparable to about 2g acceleration loading (measured with a force sensor) was applied to the collimator after the clamps were installed. The application of this load showed that the shift of the collimator (measured with a dial indicator) was within  $3\mu\text{m}$ . This deflection is within the level of drift observed in the dial indicator measurements with no load applied over a comparable time interval.

An axial load of ~14 lbf was applied/removed four times over a 60 sec interval resulting in the measured deflection shown in the plot at right. The observed 3μm deflection is within the drift of the indicator over a comparable interval with no load applied.
