August 2, 2016

Mitsuko Roberts (Caltech)

Background

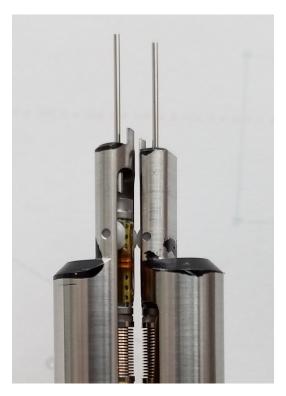
Two production Cobras were brought in during fit check of COB and rails, then it was discovered that these two Cobras (s/n C1004 and C1124) made contact at RTV, even though the body dimeters of these Cobras were checked upon receiving. This study is to further evaluate the severity of interference between Cobras on rail.

Fig 1: Two Cobras making contact with each other when installed in adjacent positions on 2 separate rails on COB
