August 2, 2016

Mitsuko Roberts (Caltech)

Background

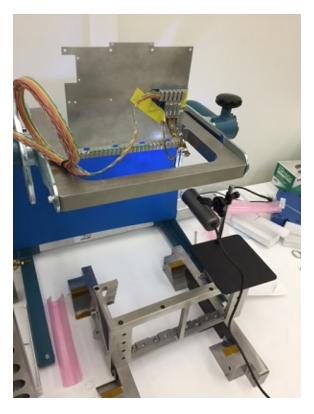
Fig 2: Rail in turn over fixture, 2 Cobras installed, driving electronics attached, and USB microscope set up for observation from side

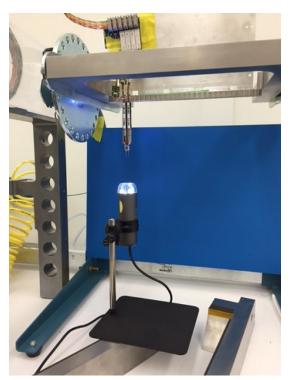
Fig 3: Observing from bottom
